**THREE CASE HISTORIES OF CRACKING PROBLEMS
ASSOCIATED WITH
STEEL BRIDGE FLOOR BEAMS**

By
W. H. Walker
M. D. Holbrook
and
P. A. Cassity

A Report on a Research Project
Sponsored by the
STATE OF ILLINOIS
DEPARTMENT OF TRANSPORTATION and the
U. S. DEPARTMENT OF TRANSPORTATION
Federal Highway Administration

DEPARTMENT OF CIVIL ENGINEERING
UNIVERSITY OF ILLINOIS AT
URBANA-CHAMPAIGN
URBANA, ILLINOIS
JUNE 1992

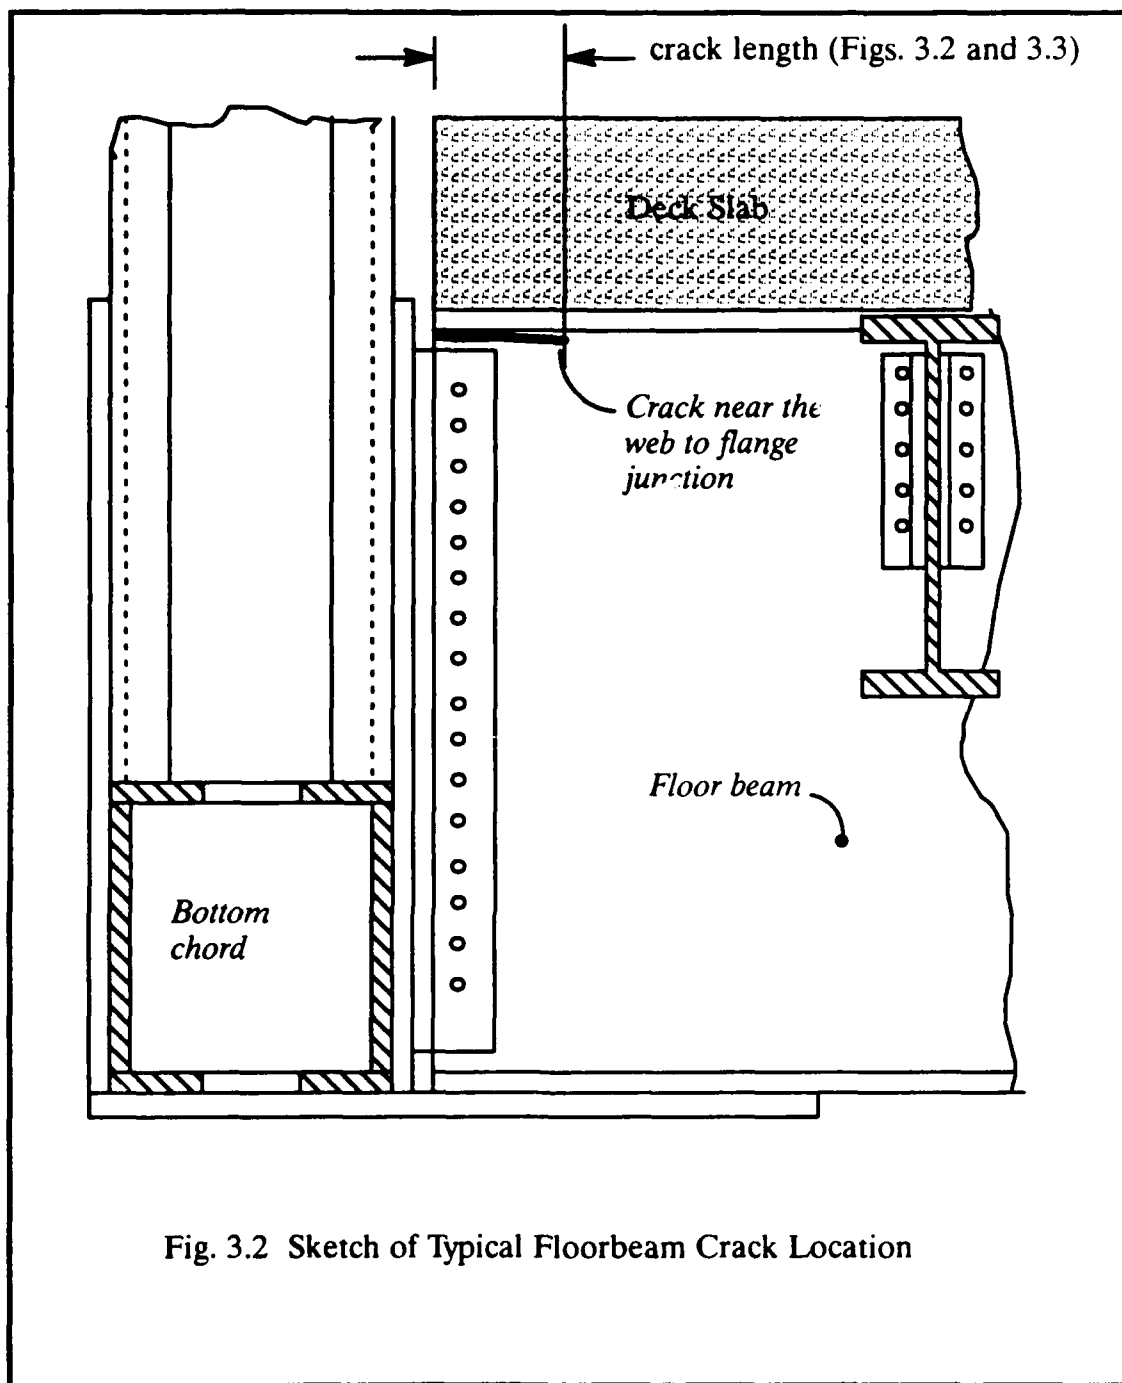
Fig. 3.3 Photograph of Typical Web Cracking in Floor Beam

Inspections (1986–1989) of the steel girder floor beams on the Shade–Lohmann Bridges revealed the existence of cracks [11] which are not attributable to expected causes. These cracks occur in the web to flange weld at the ends of the floor beam girders and are propagating horizontally inward (i.e. towards the center-line of the bridge). A typical crack configuration is illustrated in a sketch of the floor beam end with the crack location is shown in Fig. 3.2 and a typical crack is also shown in the photograph in Fig. 3.3.

The cracks typified by the sketch in Fig. 3.2 are located just slightly below the junction of the web and flange of the floor beam at the fillet weld toe. The inspection report [11, p.13] notes the following:

"The predominant and most serious defect occurring in the truss spans is cracking in the ends of the floorbeams. The cracks are in the top flange-to-web fillet weld toe at both ends of most of the floor beams and usually on both sides of the web. Holes were drilled in the webs and through welds at or near the tip of the cracks to arrest crack growth. A few of the cracks, though, have propagated past the drill holes and still others past a second hole drilled because of previous crack growth. New cracks have also been discovered in the floorbeam ends at locations where none were first reported. A few locations were also found where cracks have initiated in the webs where small tack welds were used to secure the clip angles of the floorbeam. .."

The crack location is assumed in design to be under nominally low or zero calculated bending stress (a pinned end), but the stresses measured in the field are significant. The stresses must be attributable to structural behavior outside the realm of the design assumptions. An attempt to arrest the crack growth has been made by drilling holes at the crack tips of some of the longer cracks. In a few of these cracks with drilled holes there has been re-initiation of the crack out of the drilled hole; see Fig. 3.3.

It appears that the cracks have a tendency to turn downward and grow into the web unless arrested. Growth downward in the web will serve to reduce shear capacity at this location and is of concern. It should be emphasized that this crack growth is in a region of low computed live-load stress.

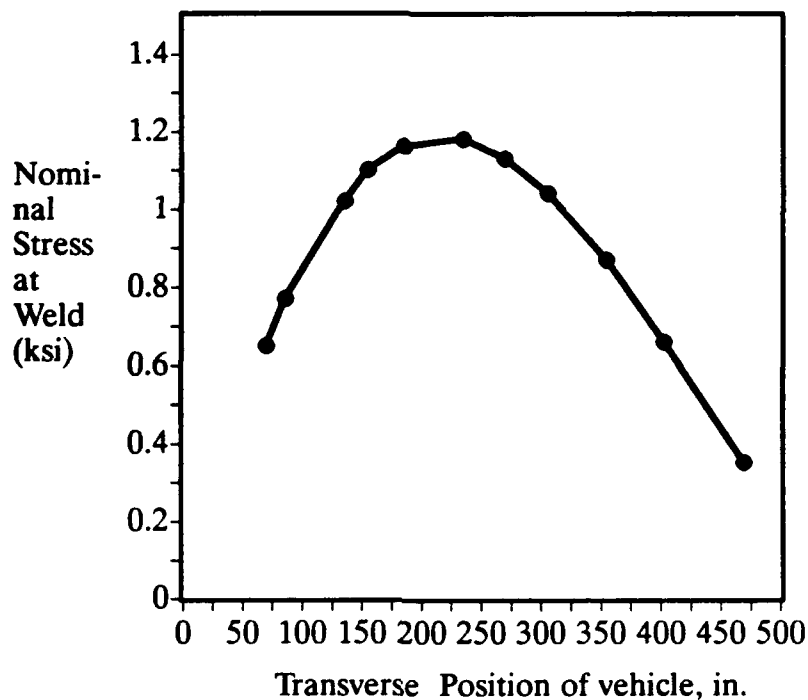
Fig. 3.6 Effect of Transverse Vehicle Position on Stress at End of Floorbeam

The flexural stress range at the crack locations was determined to be about 1.2 ksi maximum, and does not seem to be the cause of the cracking distress. The most important factor being that simple flexural stress of this prediction are parallel rather than perpendicular to the path of travel of the crack. The stress estimate assumes fully rigid connections between the floorbeam and the truss gusset perpendicular to the plane of the truss -- where in fact only shear clip angles on the web of the floorbeam are present.

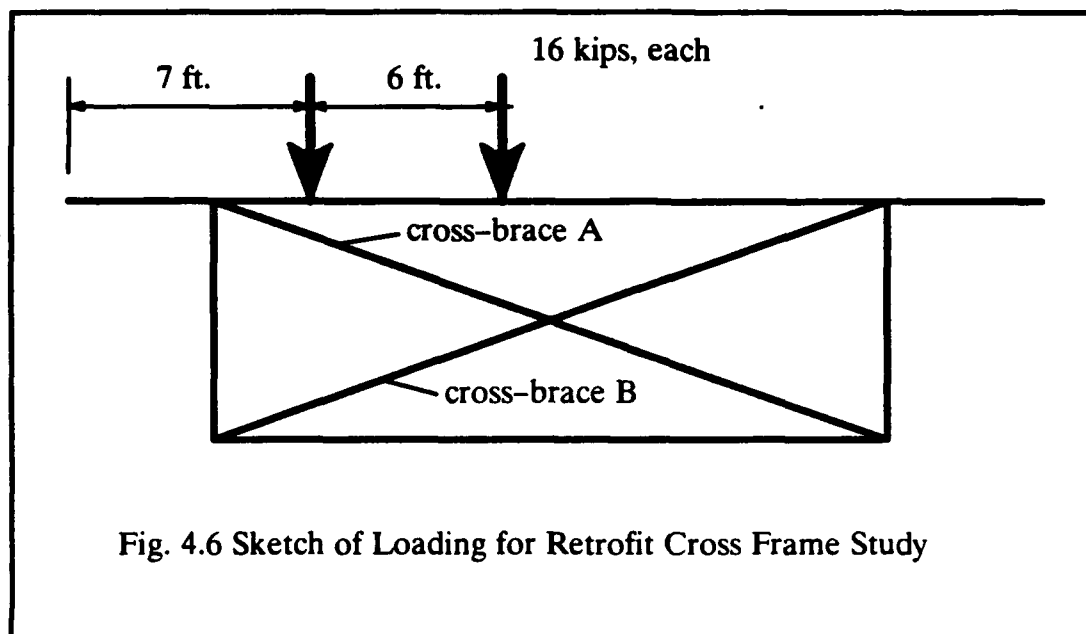
Fig. 4.6 Sketch of Loading for Retrofit Cross Frame Study

In a preliminary report by IDOT, a retrofit consisting of neoprene strain-relief devices installed in the cross-bracing was suggested to reduce the stress in the connection brackets. To investigate the results of this retrofit a 1-span 60 degree skew space frame, similar to the 3-span model, was loaded with a 32 kip axle in the position shown below in Figure 4.6.

The comparative effect of the retrofit was tested using an equivalent single span model; it was found that the additional complexity of the multispan model was not needed for this comparison. A 5.25" x 2.75" x 0.75" neoprene member element with a modulus of

elasticity of 5ksi was inserted in each of the L6" x 4" x 3/8" truss cross-braces. The retrofit reduced the axial forces in the cross-bracing approximately 80% to 95%. The resulting member forces can be found in Table 4.1.

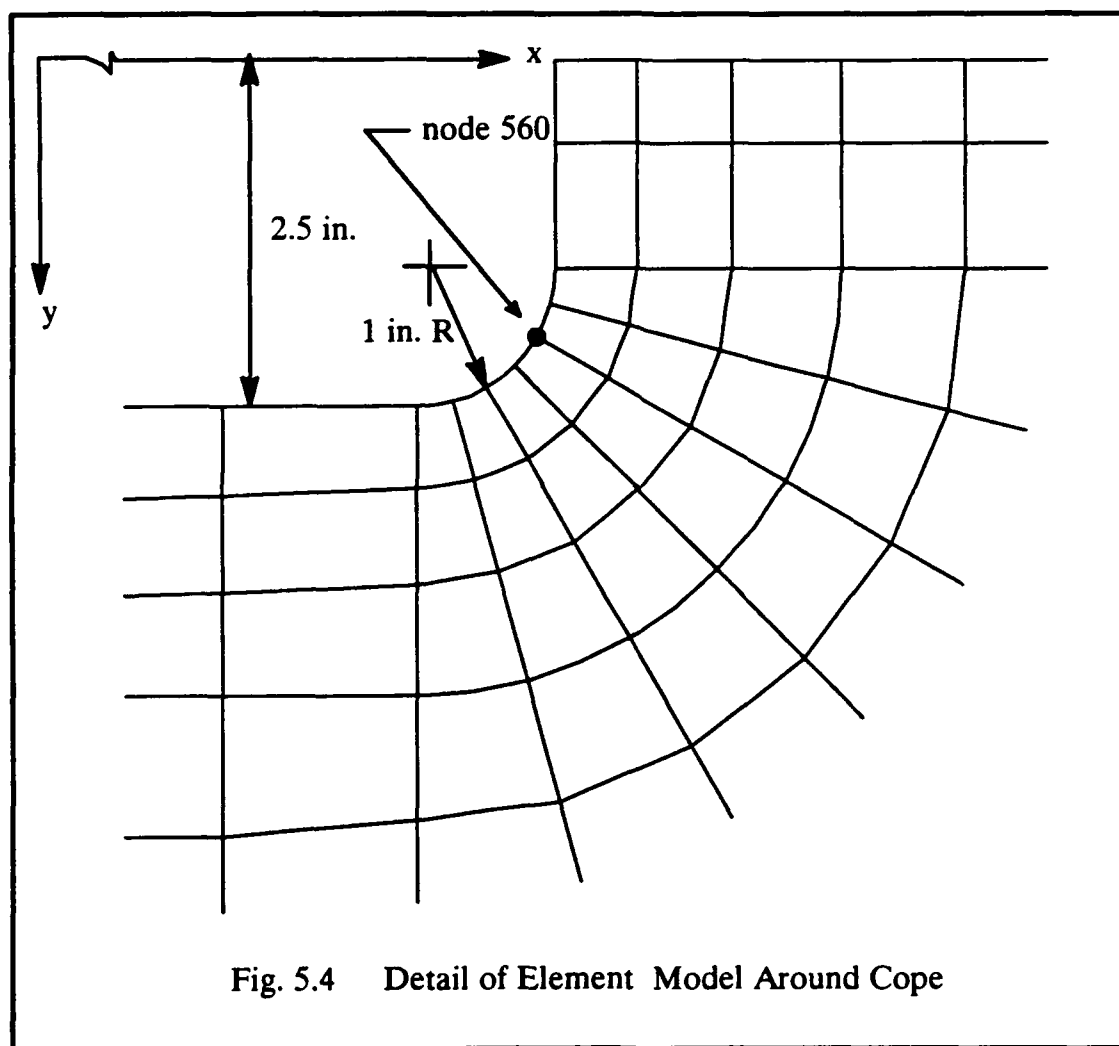
Fig. 5.4 Detail of Element Model Around Cope

Figure 5.4 shows a detail of the finite element mesh around the cope. The stresses at node 560 from the finite-element model and the stresses measured in the field are shown in Table 5.1 below. The variability of σ_x , σ_y , and τ_{xy} with position around the cope as defines by the angle, Θ , are shown in Fig. 5.5.

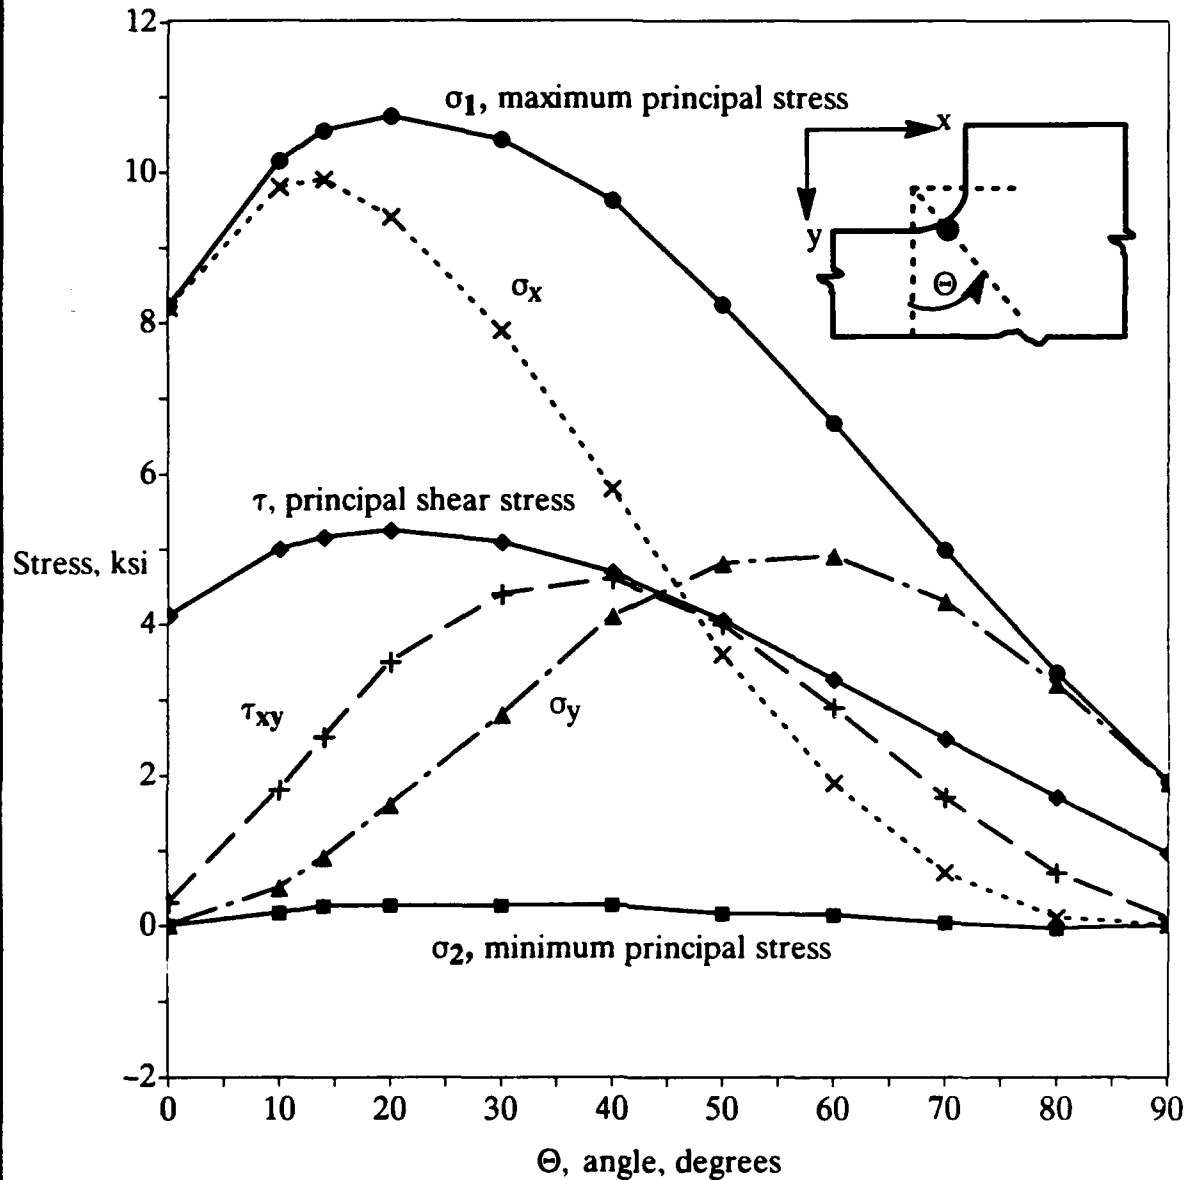
Fig. 5.5 FEM Study of Stresses Adjacent to Beam Cope

The results from the analysis are reasonably good considering that there are an infinite number of possible loading conditions and that a small two-dimensional mesh is being used to model a complex three-dimensional structure. The applied shear in the finite-element model ($V = 1.60$ kips) is very close to the resulting shear in the floor beam when the space
